# PQAO Training 2019

## Monitoring Network Design and Changes

Exercise: Monitoring Site Relocation vs. Shutdown

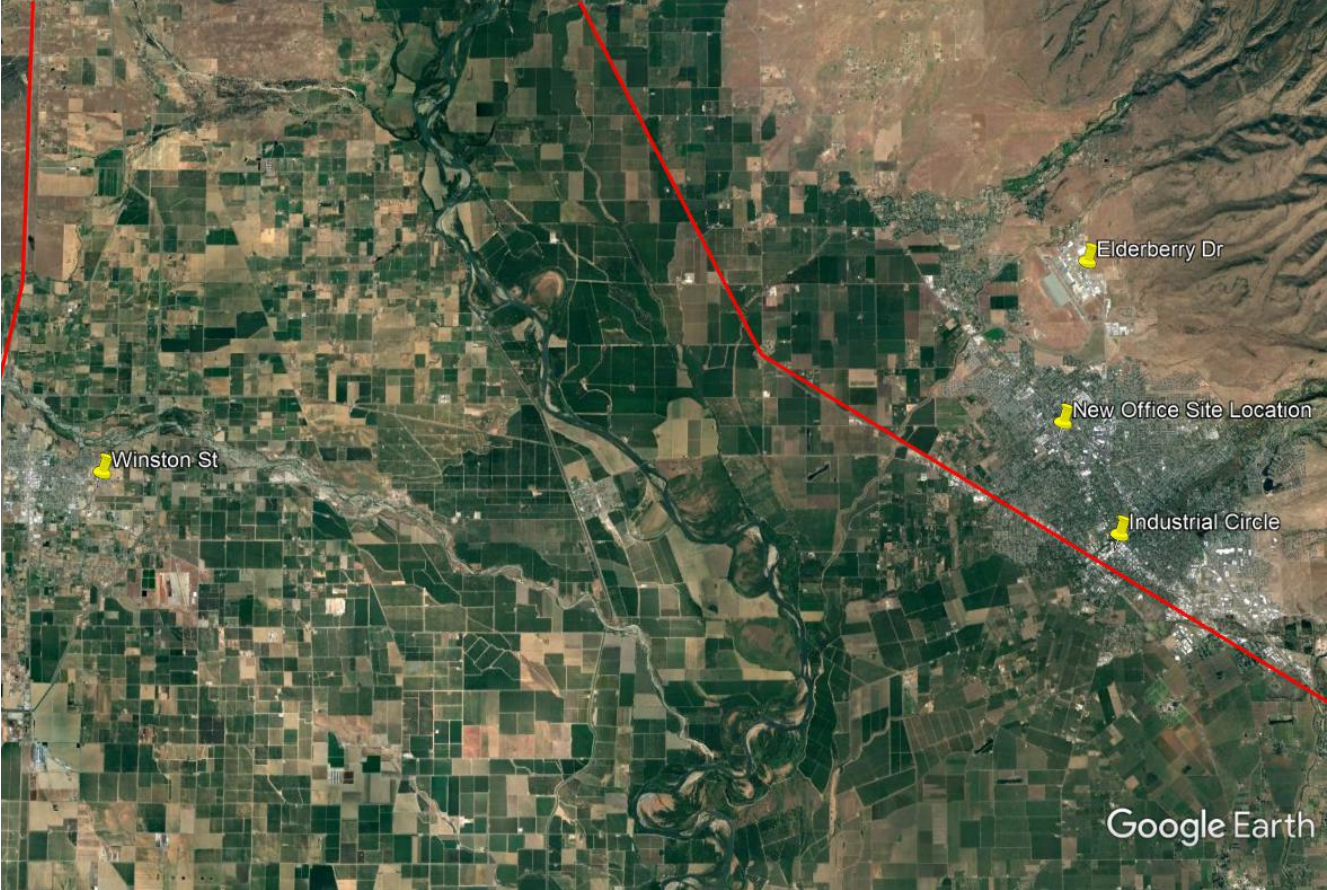
Area Map with Monitoring Sites

A metropolitan area with approximately 200,000 people has three monitoring sites, shown in the map below, and a minimum monitoring requirement of one ozone and one PM2.5 monitor. The Elderberry Dr monitoring site suffered significant structural damage during a brush fire in late summer. The fire caused irreparable damage to the building and the heat caused irreparable harm the monitoring equipment.

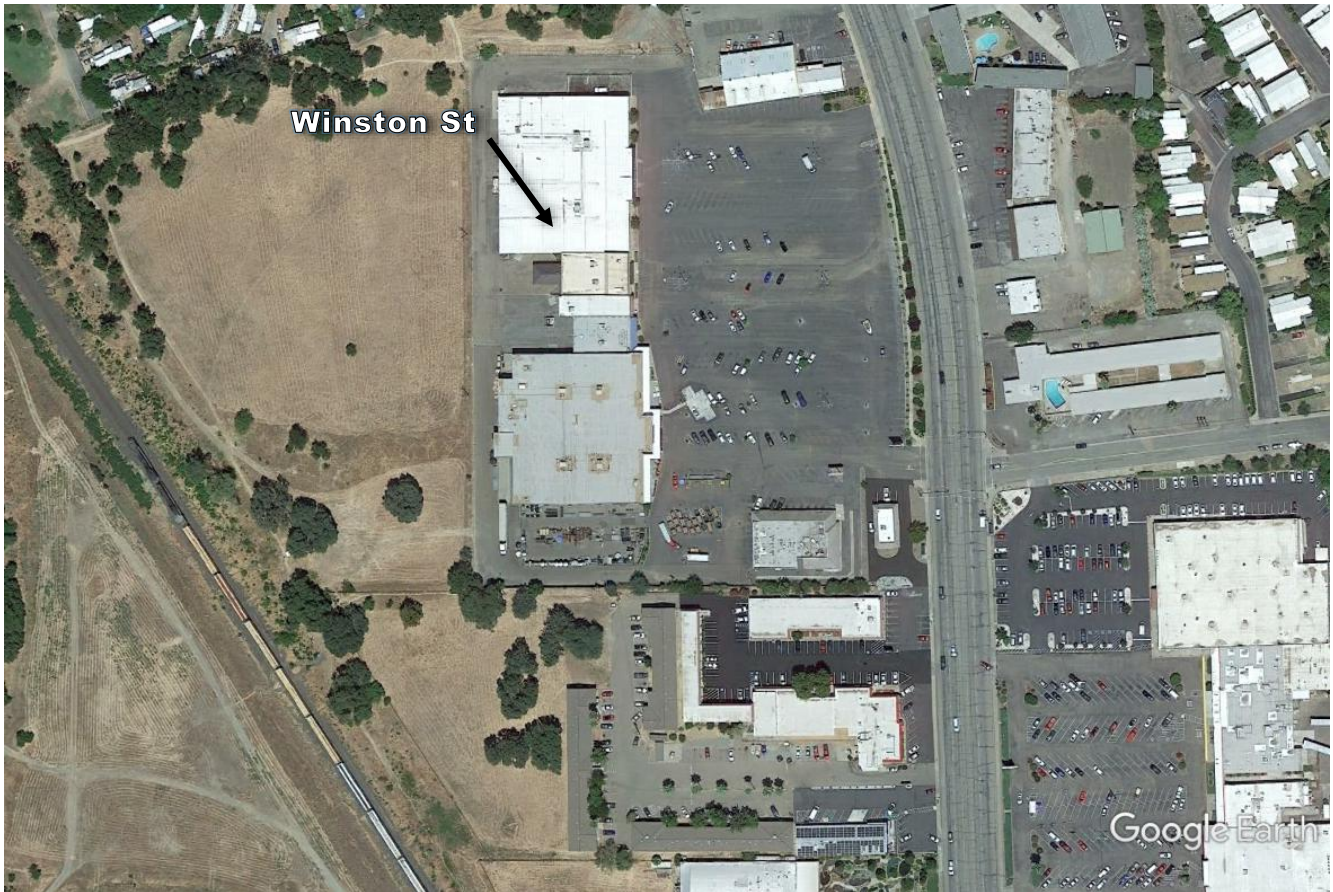
### Monitoring Site Map

Monitoring was established in 1998 in a strip mall and is located on the west side of the property. Area is mostly residential with two freight/passenger train tracks about 0.25 miles to the southwest, a major highway 2 miles to the northwest. The Elderberry Dr site is 17 miles to the northeast and the industrial circle site is about 17 miles to the east. The Site for the new office is 16 miles east.

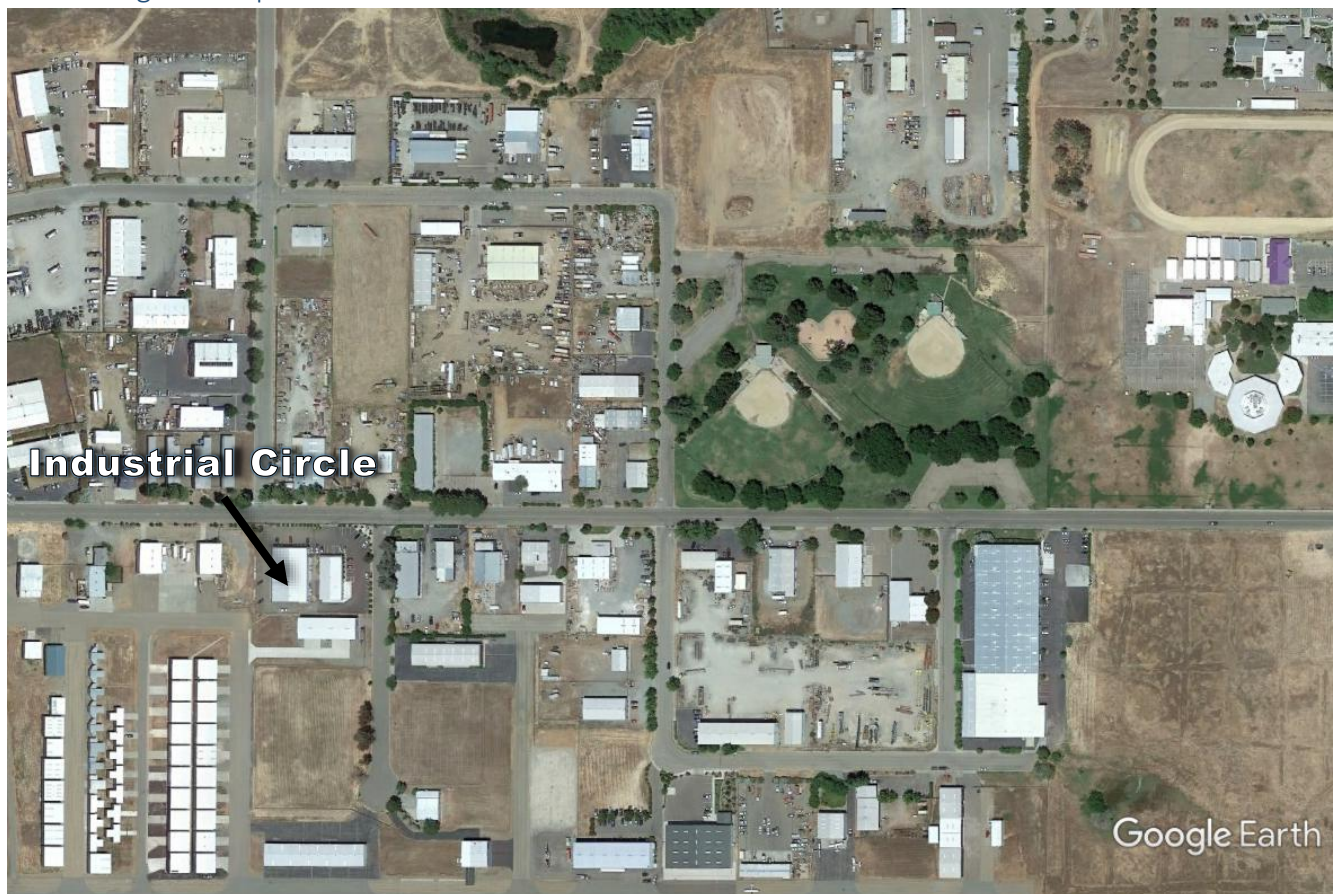
### Monitoring Site Map

Monitoring was established in 1990 at the juvenile hall service center and is located on the north side of the property. Area is mostly industrial with a large fiberglass facility about 0.25 miles to the north, a major highway 2 miles to the northwest, significant agricultural operations beginning 1 miles to the south, and a small airport facility 2 miles to the southwest. The Elderberry Dr site is 5 miles to north and the Winston St site is about 17 miles to the west. The Site for the new office is 2.25 miles north.

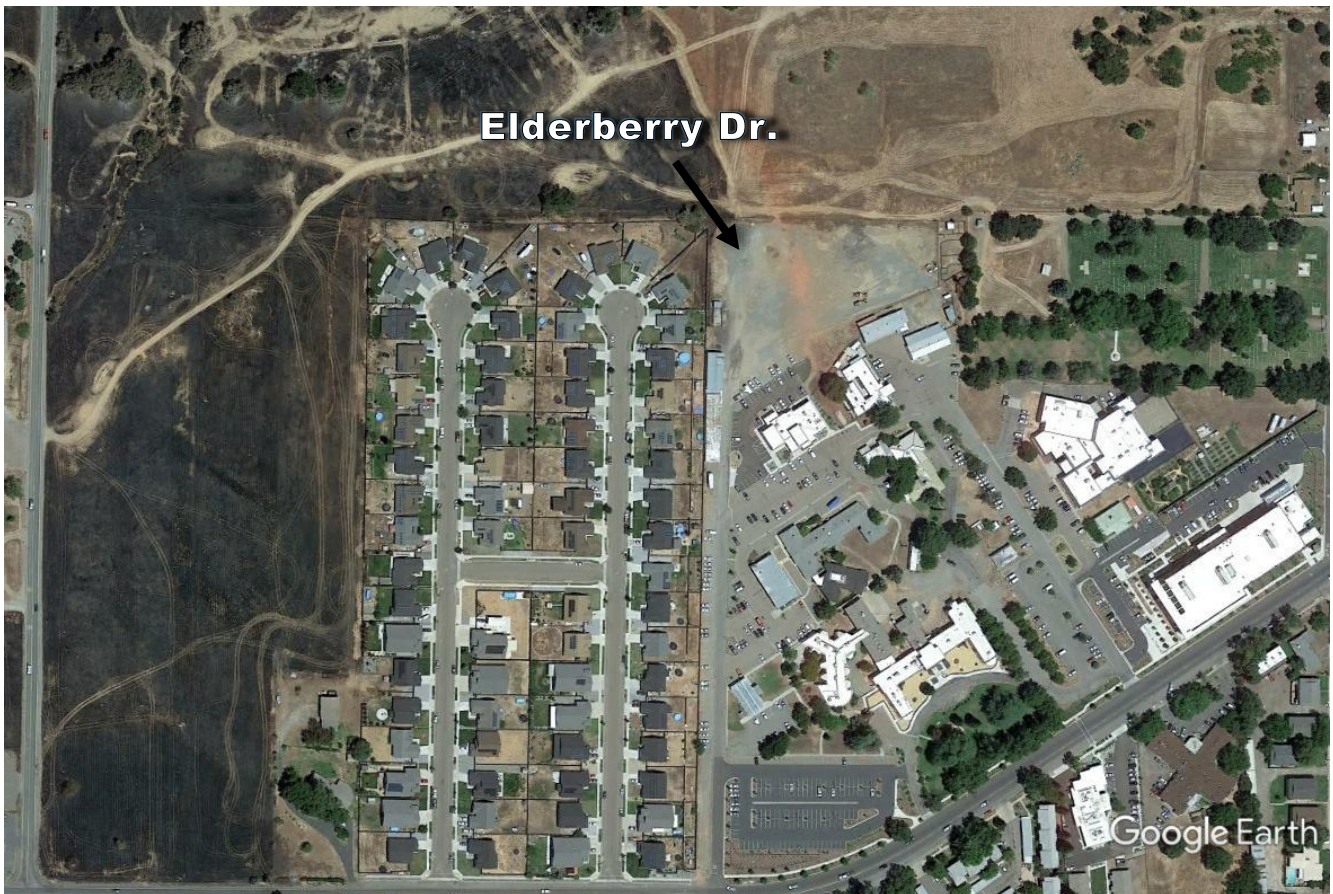
### Monitoring Site Map

Monitoring was established in 2000 at a county operated yard in an out building and was located on the north west corner of the property. Area is mostly residential with a major highway 6 miles to the west, a major retail shopping center 2 miles to the south. The Winston St site is 1 mile to the west and the industrial circle site is about 4 miles to the south. The Site for the new office is 3 miles south.

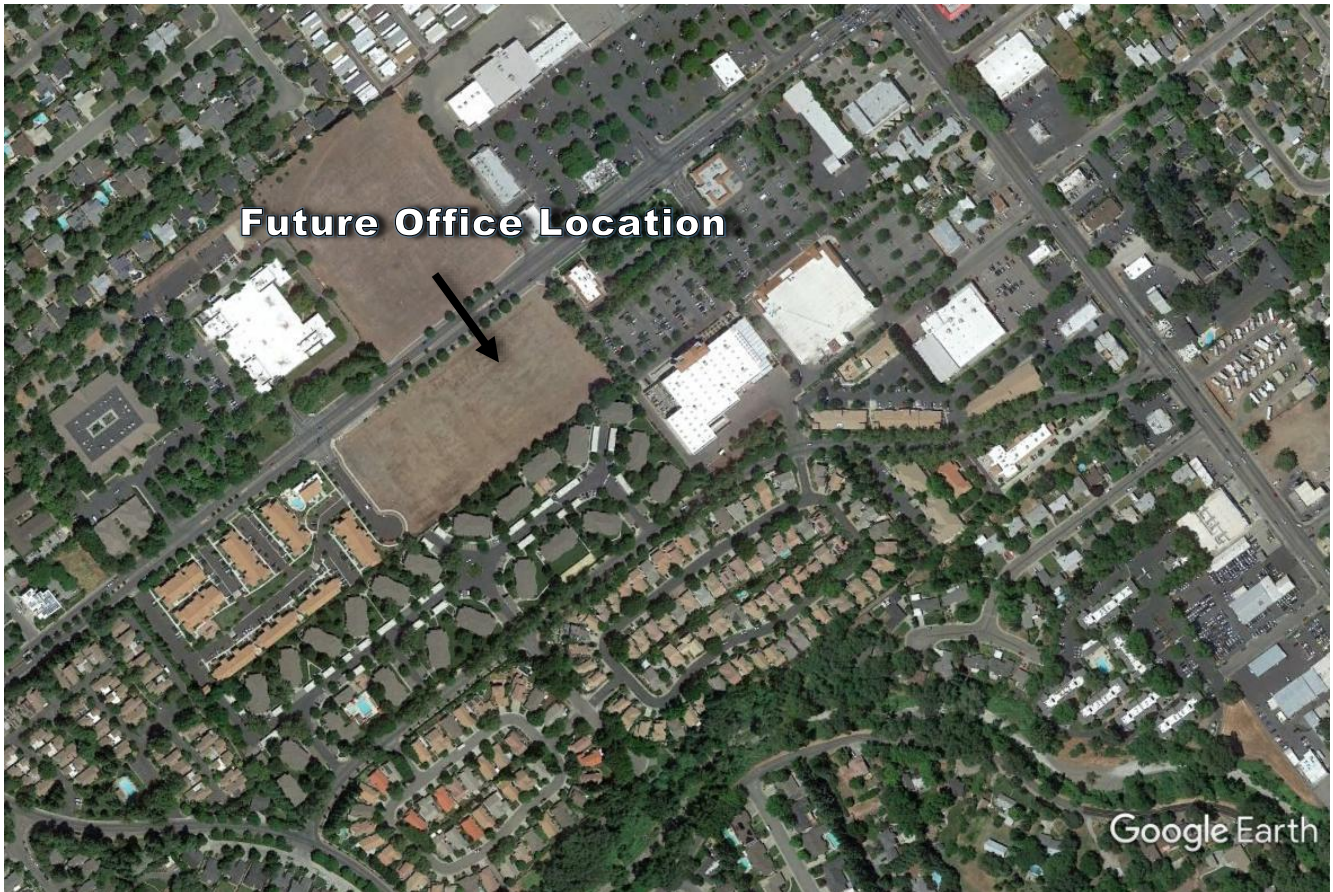
## Monitoring Site Map

No monitoring is currently occurring at this location. Area is mostly residential with a major highway 1 mile to the west, a major retail shopping center 2 miles to the east. The Winston St site is 1 mile to the west and the industrial circle site is about 4 miles to the south. The Site for the new office is 3 miles south.
